Tesla-net Metering Process

Preliminary Findings

Issue #1: Faulty Equipment

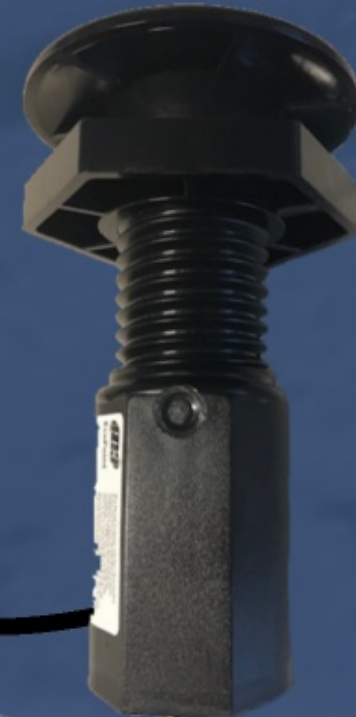
EcoPoint
(Transponder)

Stores 120 days of
consumption

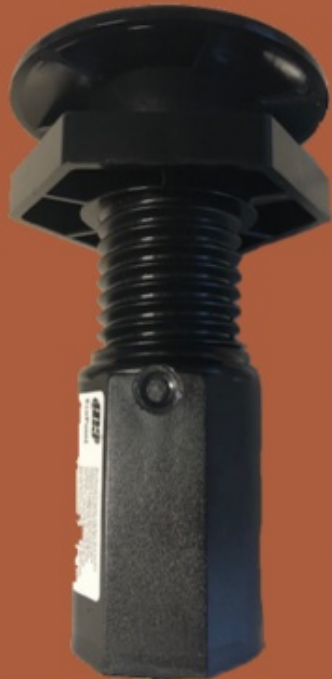
- Defective Equipment installed
 - +488 were replaced in Sept/Oct that had billing issues in 70003 series.
 - +200 are currently being replaced by RG3.
 - 2,980 still in ground with 70003 series.
- Transponders that fail either quit recording or record low usage.
- Some Transponders "come back to life" and extract or catchup on the usage from the receiver after one or two months of low usage.

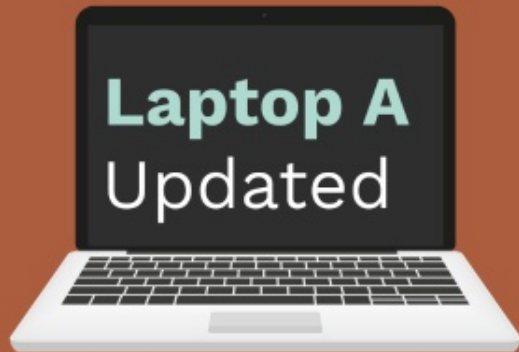
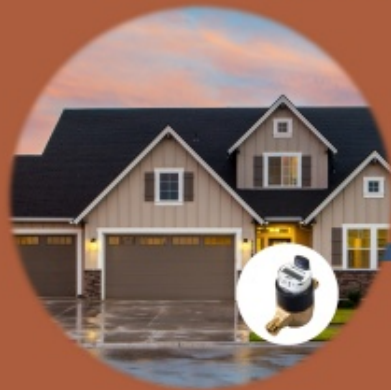
Transponder physically connected and married to receiver at House A

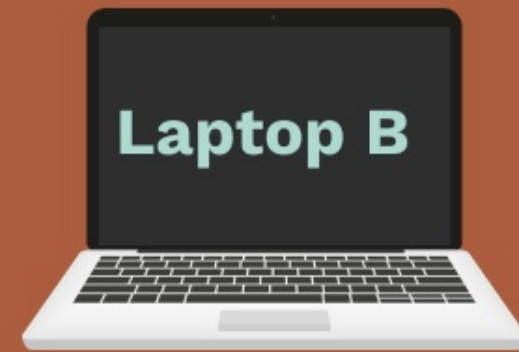
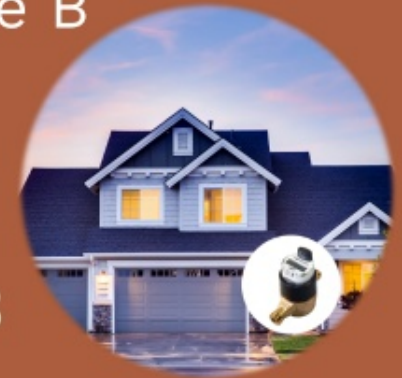
Same Transponder pulling old data showing to be married to receiver at House B

Reading extracted from Laptop B,
pulling consumption from incorrect
house/meter

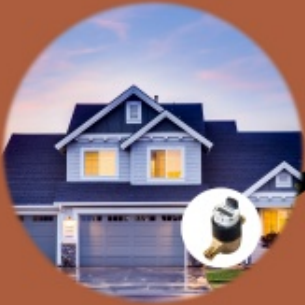
Good Connection

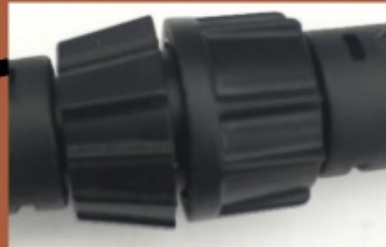
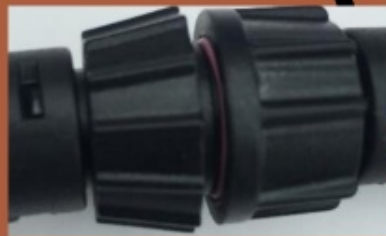
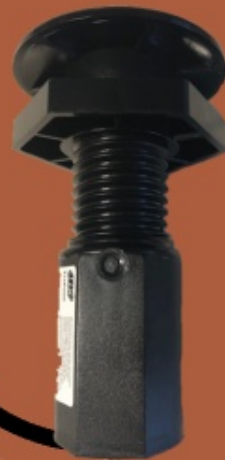
Bad Connection

- Bad Connection between register and transponder
- Register married to wrong meter (house)
